INSPECTION OF SiC_f/SiC CERAMIC MATRIX COMPOSITE SPECIMENS EMPLOYED FOR FATIGUE EXPERIMENTS VIA LABORATORY X-RAY COMPUTED MICROTOMOGRAPHY

Z. QUINEY¹, M.R. BACHE¹, J.P. JONES¹

¹ Swansea University Institute of Structural Materials, Swansea University, Bay Campus, Fabian Way, Crymlin Burrows, Swansea, SA1 8EN, United Kingdom

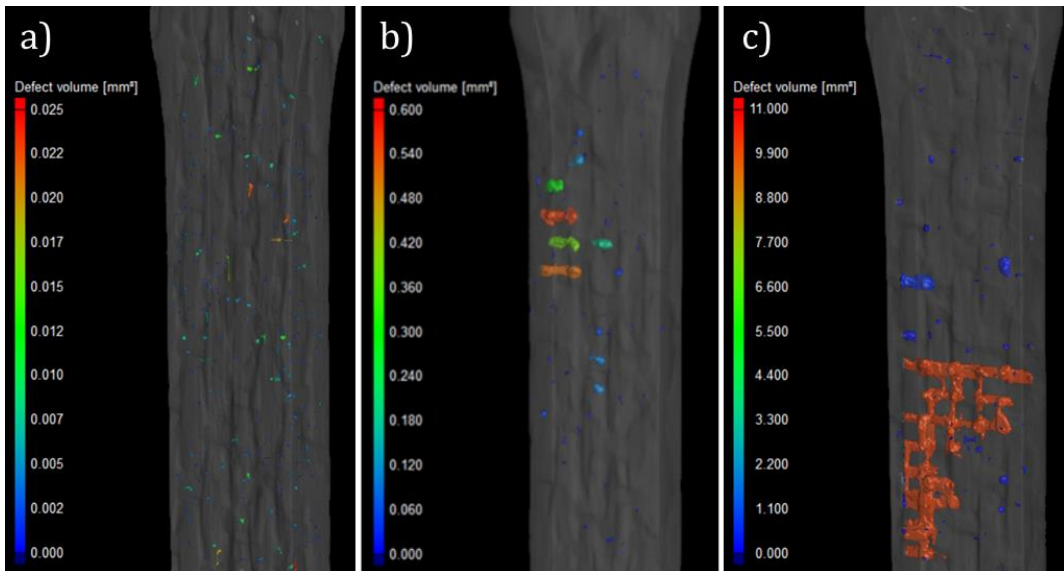
Three outputs of the void analysis are necessary to understand the nature of the void space. The % porosity indicates the presence of large voids in extreme cases such as specimen CMC010 but does not necessarily correlate with largest void size in grade I and grade II specimens. Largest void volume understandably correlates well with grade in all cases, and shows an inverse correlation with number of voids; low numbers of voids indicates that porosity is inter-connected, forming much larger distinct void spaces. Visualisation of the typical void characteristics for each grade of specimen is shown in Fig. 3.

Fig. 3: Examples of pre-mechanical test specimens of a) grade I, b) grade II, c) grade III.

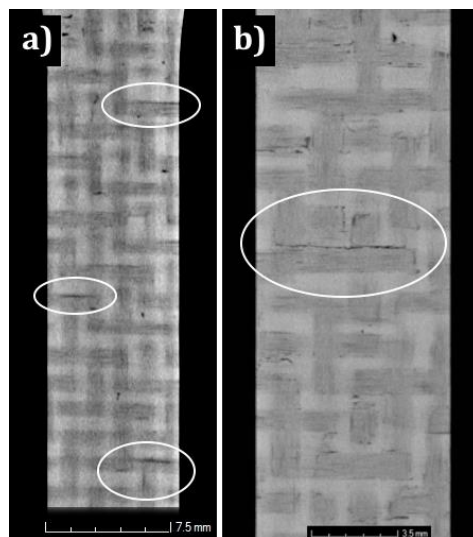
Numerous elongated void spaces could also be observed along fibre tows, likely to be caused by insufficient matrix infiltration between fibres or lack of bonding between fibre bundles and matrix. These could be observed when the voxel resolution was $64 \mu\text{m}$, but had greater clarity when the resolution was improved (Fig. 4). These “crack-like discontinuities” could be mistaken for mechanically induced cracks or delamination when detected post fatigue testing, thus it is vital to identify their existence via pre-mechanical test characterisation to avoid misinterpretation during inspection of loaded specimens.

Fig. 4: Observations of “crack like discontinuities” associated with fibre tows viewed at a) 64 μ m resolution, b) 31 μ m resolution.

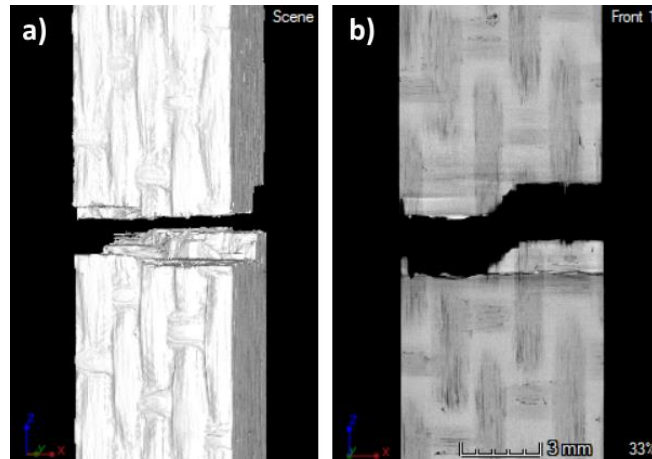
The plane of fatigue fracture varied between specimens, but was always within the 40 mm parallel gauge section. Some specimens failed close to the transition shoulder, while others such as CMC021 (Fig. 5) failed very close to the centre of the gauge length. An angled overview of this fracture is presented in Fig. 5a, indicating a relatively flat fracture orthogonal to the tensile loading axis (vertical to the page). The extent of fibre pull out parallel to the tensile axis is notably restricted. A single macroscopic step across the width of the gauge appears to be the result of the crack path deviating through the gauge thickness and governed by the 90° fibre bundles. The interface between these transverse fibre bundles and the matrix seems to provide a weak link for cracking, as viewed from the front of the specimen on a near surface plane in Fig. 5b.

Fig. 5: Post-mechanical test μ CT inspection of specimen CMC021 at 17 μ m resolution; a) angled overview, b) front view.

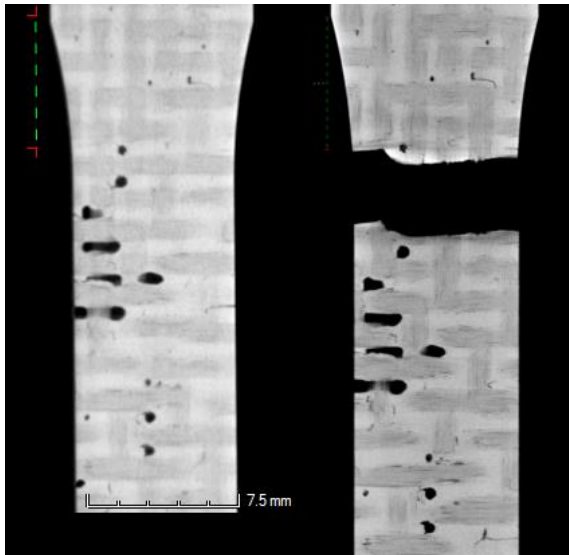
The specific influence of matrix voids and porosity was investigated. The failures observed in numerous specimens appear to indicate that large voids found in grade II specimens had no direct influence upon the fracture location. In some cases, such as CMC012 imaged in Fig. 6, although the damage zone was adjacent to a region of dense void concentration, cracking did not initiate or intersect with any of the significant voids.

Fig. 6: Pre-mechanical test (left) and post-test (right) μ CT inspections of specimen CMC012 (resolution = 67 μ m and 28 μ m respectively)

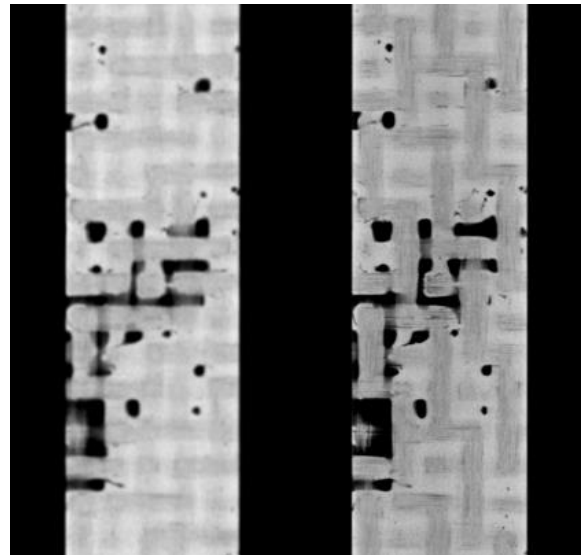
Whilst the emphasis of the present paper was to describe the qualitative relationship between processing features, our ability to identify such features, and ultimately their relationship to fatigue damage mechanisms, allows for early attempts at correlating features to fatigue life. To this end it is interesting to compare and contrast two specimens, both tested under fatigue at 550°C. Specimen CMC010 contained the largest, single, interconnecting pore amongst the whole batch of specimens at 10.23mm³, more than an order of magnitude greater than the largest pore in any other specimen, Fig. 7. This specimen actually achieved the run out condition of 10,000 fatigue cycles at a peak stress of 170MPa without fracture. In contrast, specimen CMC019, with a maximum pore size of 0.014mm³ and the smallest detected amongst the batch reported here, failed at a life of 7,974 cycles despite being tested at a peak stress just 5MPa greater. Obviously, it is impossible to say for how much longer specimen CMC10 would have resisted failure and whether the significant porosity illustrated in Fig. 7 would have been implicated in the

onset of fracture, certainly no new damage was detected via μ CT inspection at the termination of the fatigue test. However, this example goes some way to emphasise the stochastic mechanical performance of these types of ceramic matrix composites, as well as the indeterminate relationship between defects and fatigue performance.

Fig. 7: Pre-mechanical test (left) and post-test (right) μ CT inspections of specimen CMC010 (resolution = 67 μ m and 31 μ m respectively)

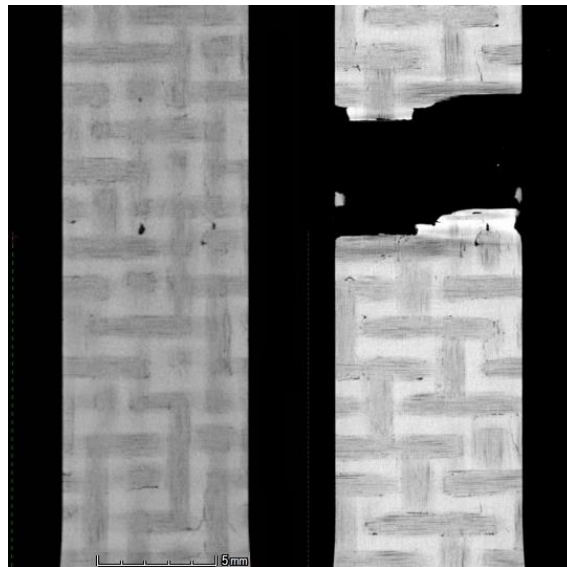
Grade I specimens, with CMC19 as a good example, indicated limited correlation between voids and failure. Occasionally the crack path interacted with a pre-existing void, Fig. 8, however, it was impossible to define the temporal relationship between the pore and failure mechanism, i.e. did the pore initiate cracking or interact with the crack growth?

Fig. 8: Pre-mechanical test (left) and post-test (right) μ CT inspections of specimen CMC019 (resolution = 31 μ m and 20 μ m respectively)

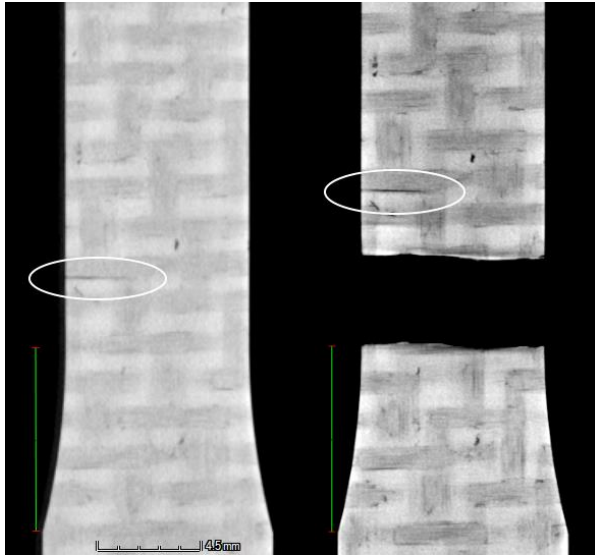
In the main, post processing crack like discontinuities, as previously highlighted in Fig. 4, did not appear to act as potent sites for true crack initiation. For example, Fig. 9 highlights that a discontinuity noted during a pre-mechanical inspection appears unaltered in the post-test inspection, despite the plane of ultimate fracture occurring just a few millimetres below. However, when the same specimen was inspected through the thickness

Fig. 9: Pre-mechanical test (left) and post-test (right) μ CT inspections of specimen CMC008 (resolution = 67 μ m and 27 μ m respectively).

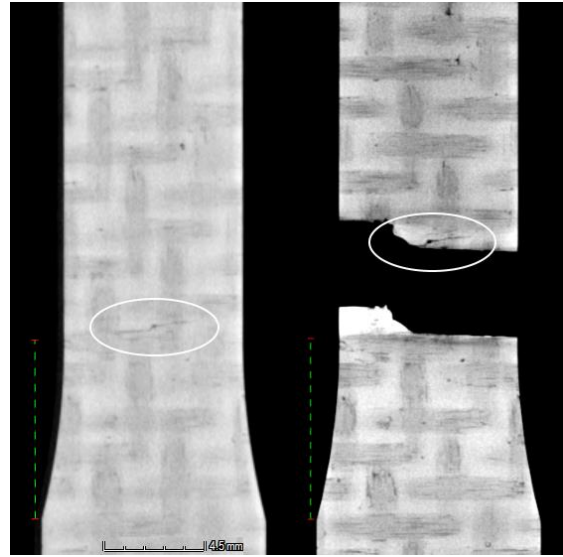
on a different vertical plane a similar sub-surface discontinuity was observed which appears to be the initiation site for ultimate failure (Fig. 10).

Fig. 10: Pre-mechanical test (left) and post-test (right) μ CT inspections of specimen CMC008 (resolution = 67 μ m and 27 μ m respectively).

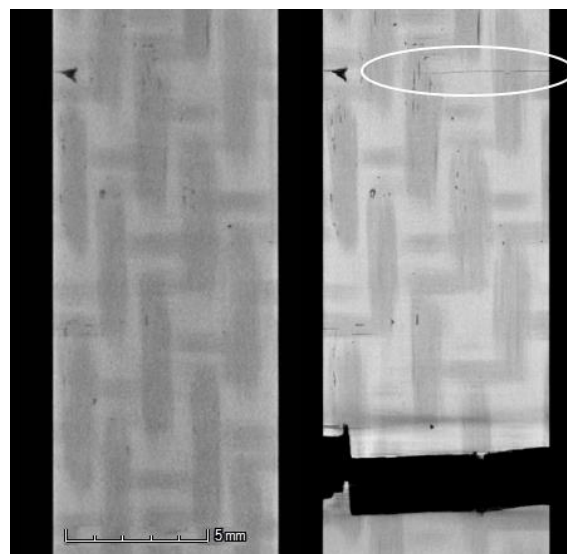
Finally, Fig. 11 illustrates specimen CMC020 where the ultimate plane of fracture was again close to the centre of the gauge length. A secondary fatigue crack was detected in the post-mechanical μ CT inspection some 14 mm away from the main fracture. This indicates that fatigue damage can initiate at multiple locations before a single dominant crack, or network of cracks, causes the ultimate failure. The sub-critical fatigue crack clearly differs from the process discontinuities as it traverses both 0° orientated fibre bundles and the matrix. No feature was indicated at the corresponding location prior to mechanical testing. The crack was detected on numerous sub-surface images, helping to define a quarter elliptical profile at the corner of the gauge section, 1.5 mm through the thickness of the section and 5.5 mm in front surface length.

Fig. 11: Pre-mechanical test (left) and post-test (right) μ CT inspections of specimen CMC020 (resolution = 31 μ m and 17 μ m respectively).
