# CHARACTERIZATION OF PRODUCTION-INDUCED DEFECTS IN CARBON FIBER REINFORCED THERMOPLASTIC TECHNOLOGY

Frederic J.C. FISCHER<sup>1\*</sup>, Yannick MEZAKEU TONGNAN<sup>1</sup>, Matthias BEYRLER<sup>1</sup>,  
Tobias GERNGROSS<sup>1</sup>, Michael KUPKE<sup>1</sup>

<sup>1</sup> Deutsches Zentrum für Luft- und Raumfahrt (DLR) e.V., Zentrum für  
Leichtbauproduktionstechnologie (ZLP), Am Technologiezentrum 4,  
86159 Augsburg, Germany

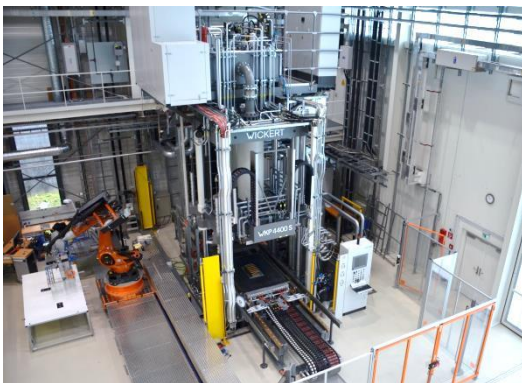
**Figure 1:** Thermoplastic production cell at ZLP

At ZLP tailored organic sheets and curved preforms are produced in an automated manufacturing cell by stacking and ultrasonic welding of thermoplastic prepregs. The respective weld parameters have been established in a preliminary study [1].

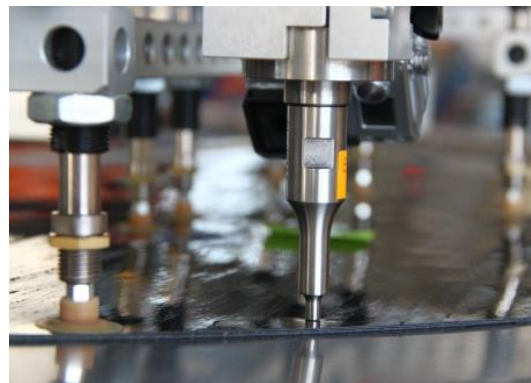
**Figure 2:** Ultrasonic horn integrated in an end effector for the spot welding of laminate stacks

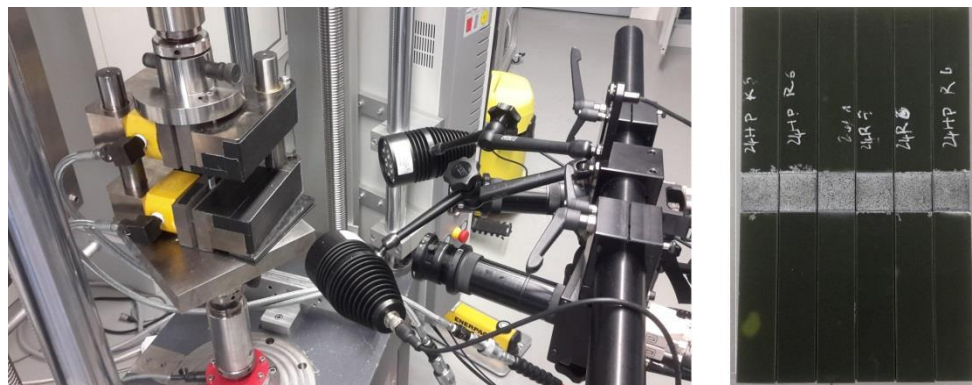
The sample is mounted between four jaws and fixed with a hydraulic clamping device. The tests are performed with a test speed of 1.3 mm/s. Figure 9 shows the experimental setup and six test specimen with speckle pattern.

**Figure 9:** Compressive loading setup and Aramis 12M measuring system (left);

Test specimen with speckle pattern (right)

A ZWICK KAPPA 050 DS testing machine was employed with a combined loading compression test fixture along with the GOM Aramis 12M system. The latter allows the non-contact measurement of 3D displacement and strain during compressive loading.

Before testing a speckle pattern is sprayed on the samples. Two CCD cameras record the sample during testing. The measuring software compares the change of the pattern with reference images and calculates the deformation of the sample. The sample is illuminated during the test and the recording frequency of the cameras is 2 Hz.

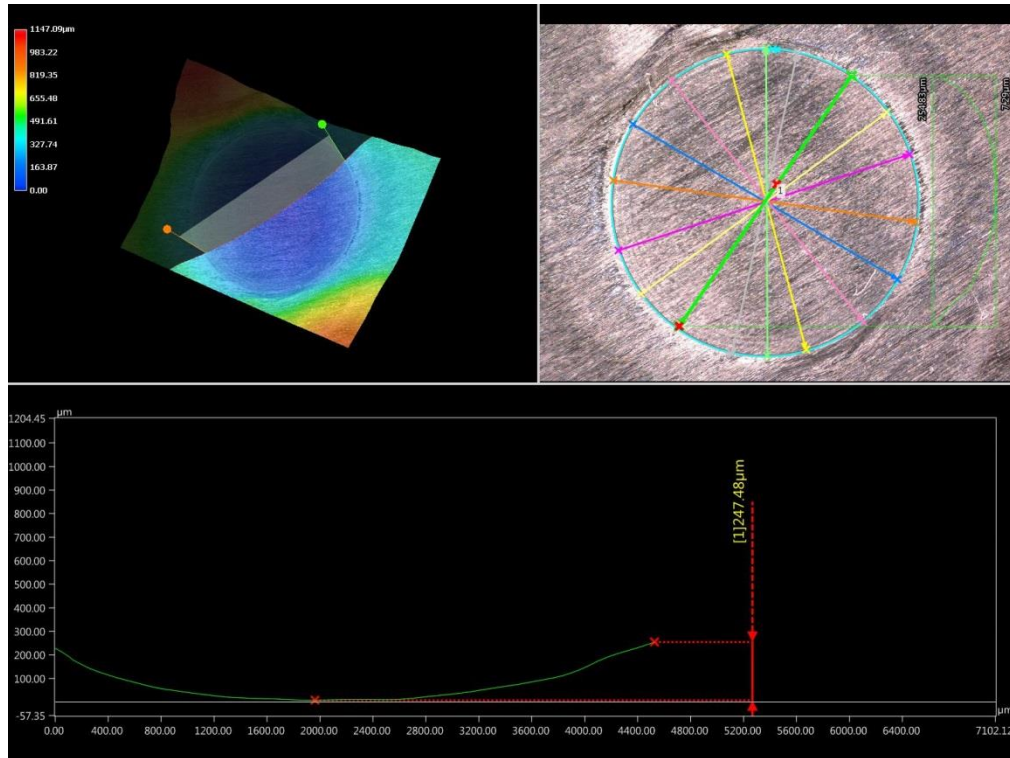
Depth and diameter of each weld spot was measured prior to consolidation (see Figure 13). The 5 mm horn leaves a clearly visible imprint on the laminate stack surface, at times even with noticeable fibre fracture. For the laminate stacks welded at contact pressures of 5.5 MPa and 6.7 MPa the imprints are about  $4.6 \text{ mm} \pm 0.3 \text{ mm}$  in diameter and roughly  $210 \text{ } \mu\text{m} \pm 70 \text{ } \mu\text{m}$  deep. The depth measurements are subject to variations as the uncompacted stack shows waviness at the weld spots (see Figure 13).

**Figure 13:** 3D-model and profile measurement of the very same weld spot

After consolidation during which fibre wetting and sample compaction takes place the measurements were repeated. The imprints remain distinct atop the compacted sample, the previously disrupted fibres are clearly recognizable and dry areas without proper wetting remain. The surface, however, is more reflective due to the homogenous distribution of the matrix. Quantitative measurement of the depth of the imprints after consolidation is not feasible.

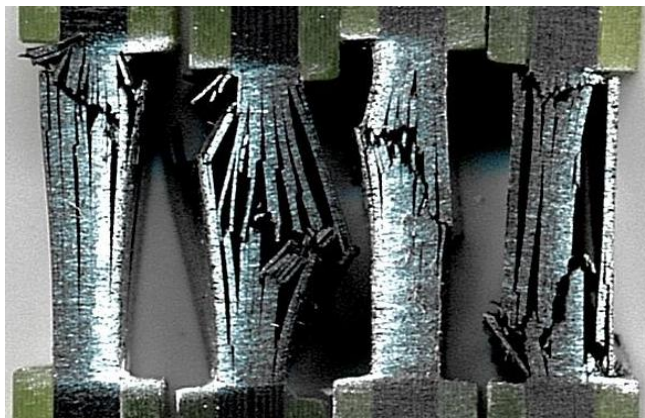
Specimen with and without weld spots were tested according to ASTM D 6641/D 6641M (Procedure B). After compressive failure all of the samples showed an acceptable failure mode (see Figure 19). The experimental results are thus valid.

**Figure 19:** Example of four successfully tested specimens with acceptable failure modes and areas according to ASTM 6641

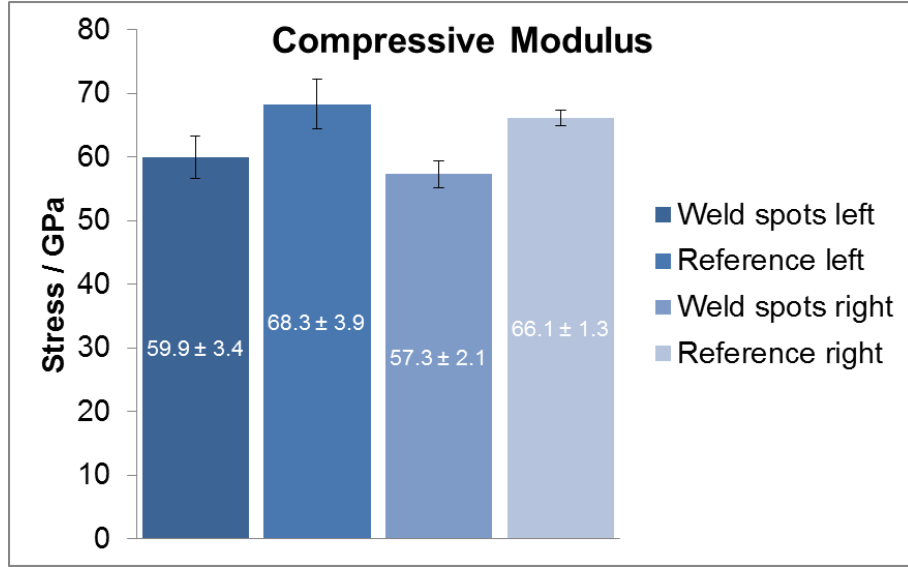
The obtained mechanical moduli are compiled in a bar chart and show rather small statistical variation (see Figure 20). The compressive moduli of the spot-welded samples are significantly lower than those of the reference samples for both sets of tested welding parameters (compare Table 1). Buckling sets in at lower stress levels and leads to an earlier failure. The differences between the differently welded specimens are within the range of the measurement error. The same is true for the differences of the reference samples.

**Figure 20:** Compressive modulus of the samples with weld spots of a 5 mm horn and their respective reference samples without weld spot

In general it is challenging to obtain good values for mechanical performance factors in composites, especially under compressive loading [9]. Typically complex stress states are found in compression test specimens [10]. In this context the obtained values are clearly reliable and useful. The obtained stiffness values for the reference samples are within the

expectable limits and significantly higher than those with weld spots.

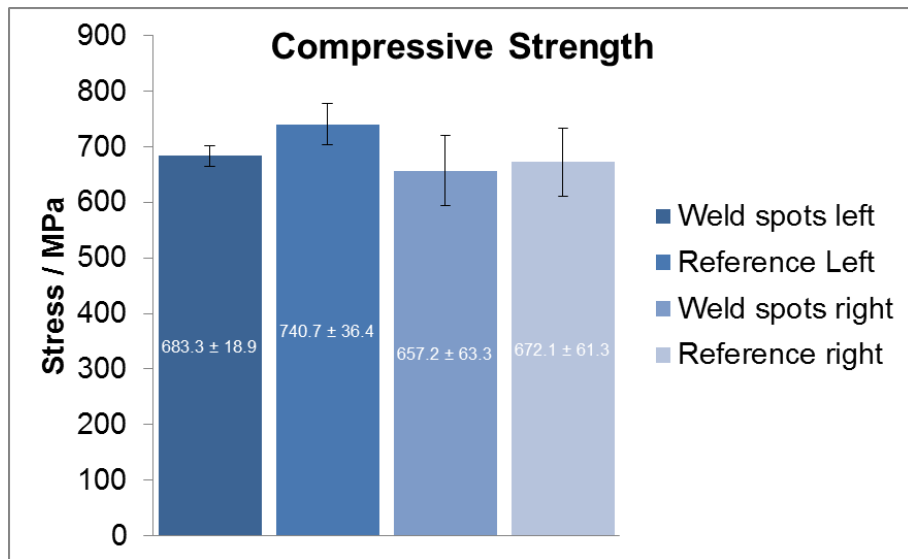
The variation of the measured compressive strength shows no distinct significance especially for the specimens welded at higher contact pressures. The overall standard deviations are within reasonable and acceptable range (3% - 10%). The obtained values of the test series with weld parameters at a higher contact pressure of 6.7 MPa (right row) generally show lower strength values at higher standard deviations.

**Figure 21:** Compressive strength of the samples with weld spots of a 5 mm horn and their respective reference samples without weld spot
