INSPECTION OF SiC_f/SiC CERAMIC MATRIX COMPOSITE SPECIMENS EMPLOYED FOR FATIGUE EXPERIMENTS VIA LABORATORY X-RAY COMPUTED MICROTOMOGRAPHY

Z. QUINEY¹, M.R. BACHE¹, J.P. JONES¹

¹ Swansea University Institute of Structural Materials, Swansea University, Bay Campus, Fabian Way, Crymlin Burrows, Swansea, SA1 8EN, United Kingdom

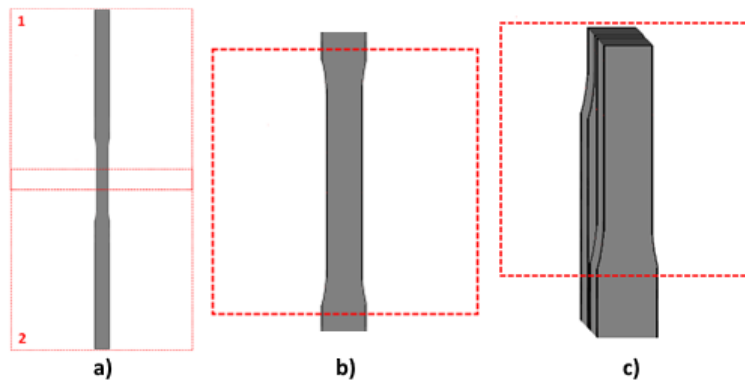
Fig. 2: Specimen ROI configurations for μCT : a) separate pre-mechanical test scans of top half (1) and bottom half (2) with overlap, b) single pre-mechanical test scan of gauge section, c) single post-mechanical test scan of fractured portions.
