# DEVELOPMENT AND DEMONSTRATION OF AN AUTOMATED SYSTEM FOR LIMITED ACCESS WELD INSPECTION BY USING INFRARED ACTIVE THERMOGRAPHY

The goal of this work has been to develop a method and to present a system able to locate, quantify and size weld defects such as surface cracks in hidden welds in an aero engine component.

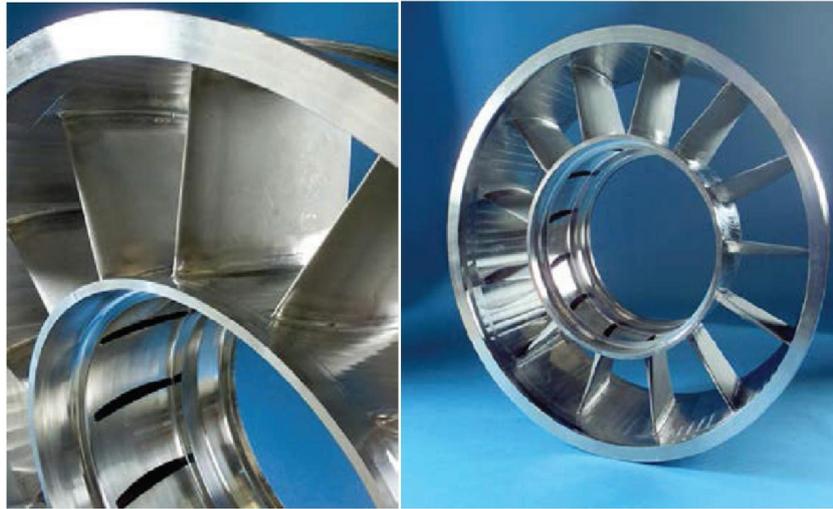
**Figure 1. Turbine Exhaust Case: fabricated non-rotating turbine exit component which is located after the low pressure turbine within a jet-engine**

For fabricated components and structures, such as the component shown in Figure 1, different inspection and NDT methods are today being used for weld inspection. Reliable detection of defects and inspection of weld geometry is critical with respect to component life and flight safety. Current techniques such as Visual Inspection, Fluorescent Penetrant Inspection (FPI), Eddy Current and Radiography have limitations in applicability and detectability, especially for inspection of parts with complex geometries and difficult to reach access, such as the inside of the guide vanes of the component shown in Figure 1. This may thus reduce the design freedom which may result in a poorer and possibly heavier component.

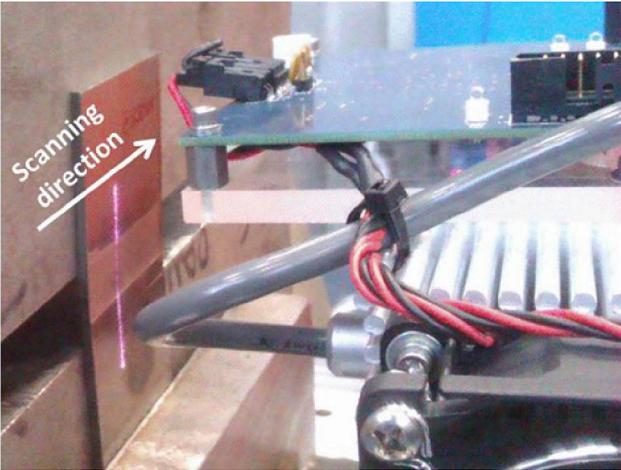
Among different laser excitation strategies that can be applied (pulsed laser, spot-heating...), the laser line excitation is an interesting strategy given the nature of this challenge. The major advantages of this method include the application of excitation in a more controlled manner compared with other excitation methods which makes the analysis step much easier. Besides, it makes it possible to excite the entire welded region in a single scan. Additionally this method allows the analysis of a single line instead of the whole imaging increasing the processing speed. In this case, see Figure 2, a set of lenses were used to generate a thin line. These set of lenses may be modified according to the inspection requirements.

Figure 2. Laser scanning system on a welded plate.

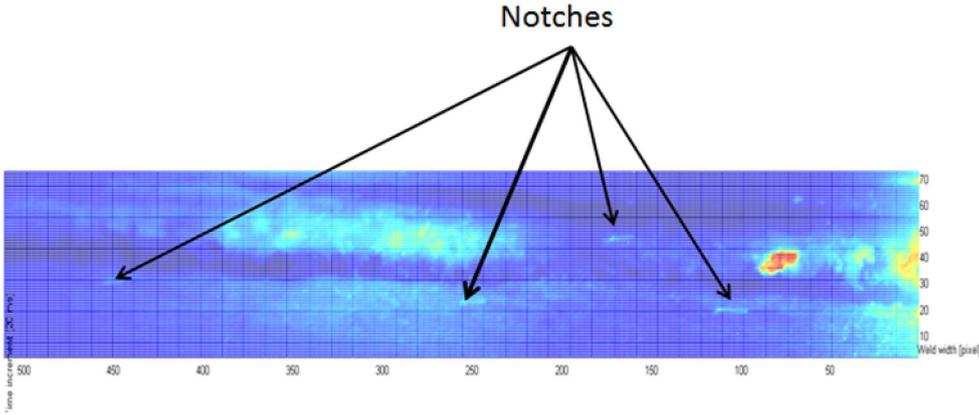
Some test evaluations were made with welded plates, and the results are presented here. Two different samples were analysed all of them containing EDM-manufactured (Electro Discharge Machining) artificial defects. In both cases the width of the notches was about 0.1 mm, the length between 0.76 and 3 mm and the depth between 0.38 and 1.5 mm. In both samples (see Figure 3), notches were clearly detected but also non-defective areas, such as surface irregularities and oxides areas due to over-heating. Due to this, distinguishing between defective areas and false positives can be a problem unless other more advanced processing techniques are used.

Figure 3. Sample result after line scanning ( $P=30 \text{ W/cm}^2$ ). The presence of the notches can be detected

by the given thermal contrast.

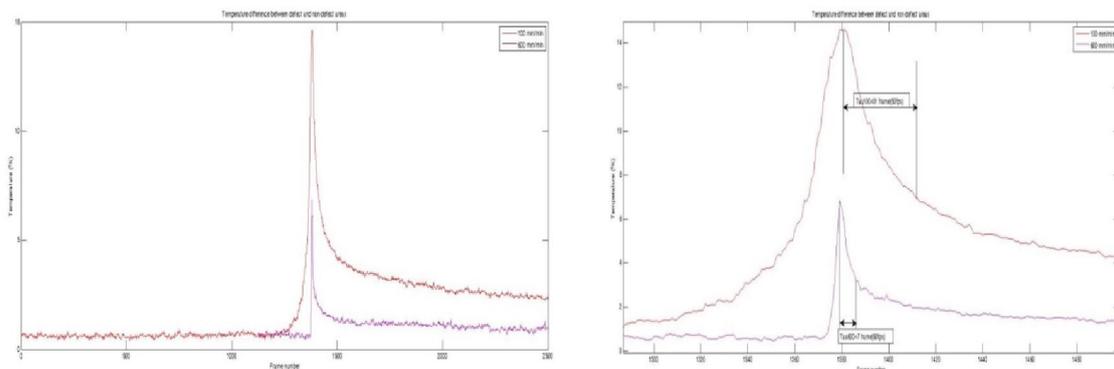
After this analysis two main conclusions were drawn. With respect to temperature increment, it was observed that radiation increment (which is the equivalent to temperature increment) may be reduced by a factor of 2 when increasing the scanning speed from 100 mm/min to 600 mm/min. In addition to this, the transient response may also be affected, which clearly represents a key aspect in the analysis part. The parameter that represents this behaviour in the temporal processing is the time constant of the cooling curve. Due to scanning speed increment the time constant is reduced considerably to 7 frames, as can be seen in the image (see Figure 4). This obviously represents a challenge when trying to characterize the thermal response that may determine whether the area is defective or non-defective. Due to this fact, the scanning speed with the current system was bounded between 100 mm/min and 500 mm/min.

**Figure 4** Temperature differences at different speeds (image on the left) and the corresponding cooling behaviour (image on the right)

In addition to the minimum detectable size, the scanning speed also affects the resulting temperature increment and therefore, detectability (due to differences in the absorbed energy). For this assessment, some experiments were carried out by keeping the camera and the work piece stationary while the laser scanned the defects at a constant velocity. Tests were conducted at 50 Hz acquisition rate.

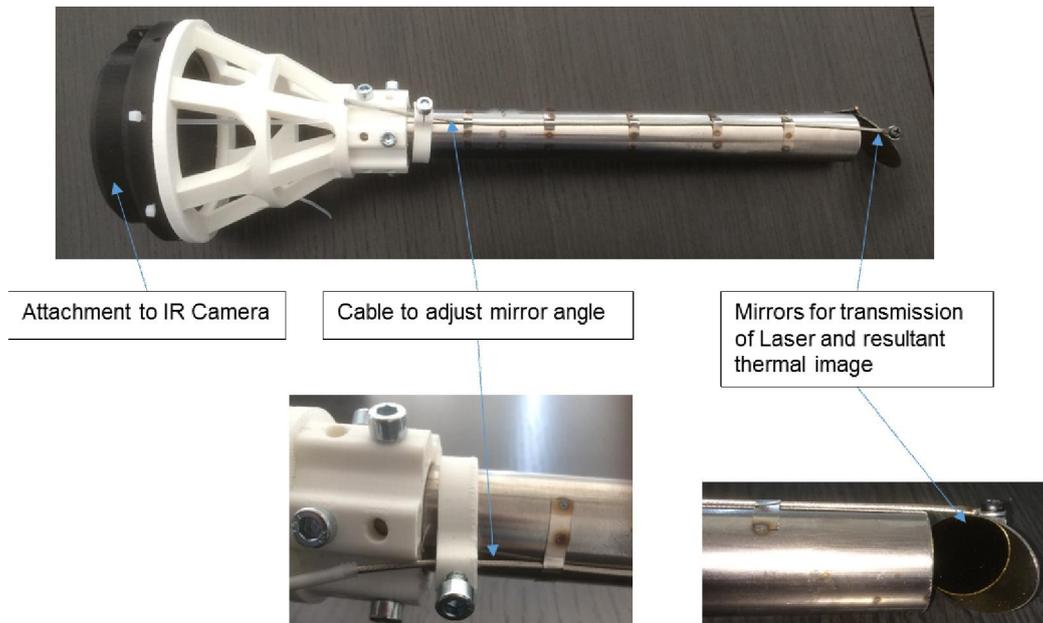
Figure 5. First prototype of borescope.

This first prototype, see Figure 5, was tested and found to work, but it had some design issues that had to be addressed.

- The mirror had only one angle of movement change, therefore 2 mirrors with separate adjustment would have to be used.
- The borescope was too large and inflexible for the application. Something more flexible would have to be designed so that the mirrors could easily be manipulated into the small opening.

As mentioned before a prototype holder (borescope), with a set of 2 mirrors attached, was designed and produced. The holder was attached to the IR camera and the laser was placed alongside at an angle that allowed the alignment of both to the object under inspection.

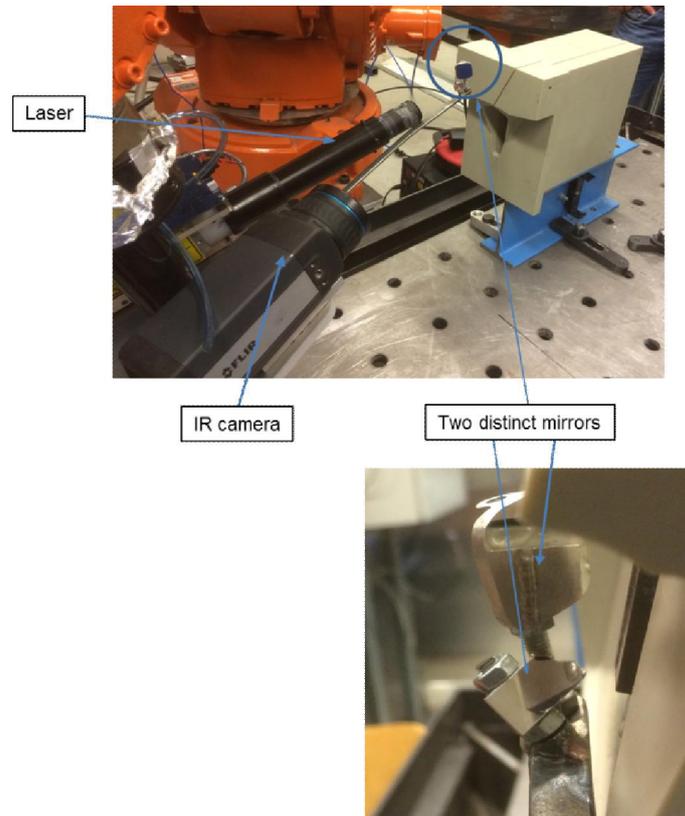
The final design, the second prototype, for the mirrors was somewhat different and was not connected directly to either the laser or the thermal camera, but directly to the manipulation robot, see Figure 6. The laser and the thermal camera were also placed on the arm of the robot to ensure cohesion between all three components of the system. In the mirrors the image of the weld can be clearly seen, see the lower part of Figure 6. The adjustment of the angles of the mirrors, in this case, was done by hand. In future this adjustment would be carried out automatically or remotely using small actuators.

**Figure 6** Second prototype of borescope solution mounted in the final NDT cell for weld inspection inside a mock-up of a guide vane with limited access.

This second prototype was tested and demonstrated in the final NDT cell.
